# RECOGNITION

# REPAIR

## OF HAIL-RELATED DAMAGE ON CEDAR SHAKES AND SHINGLES

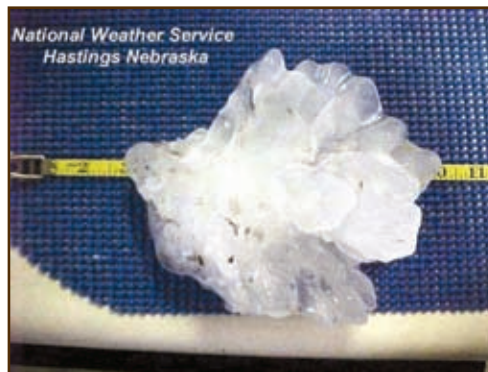
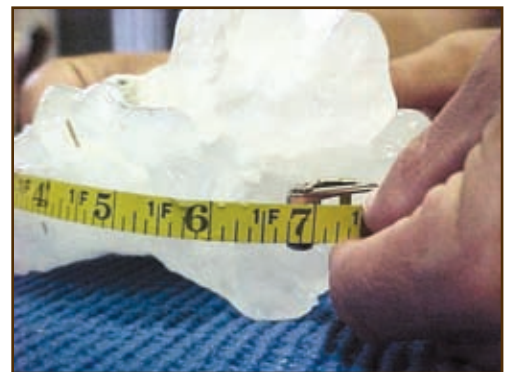
The largest hailstone ever confirmed by the National Weather Service measured 7 inches in diameter and 18.75 inches in circumference and fell in Aurora, Nebraska, in 2003<sup>3</sup> (see *Photos 1A and 1B*).

*Photos 1A and 1B – Pictures of the record-breaking Aurora, Nebraska, hailstone. Since the hailstone struck a house roof in its descent and partially broke, an accurate weight of the hailstone was not possible. Property damage from the storm was estimated at \$500,000, with \$1 million in crop damage across Hamilton County, Nebraska (NCDC 2003). Large hail left craters in the ground up to 14.0 inches (35.56 cm) in diameter and 3.0 inches (7.62 cm) deep. National Weather Service photo.*

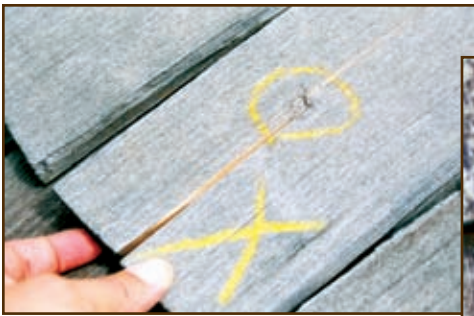
Photo 2A – Hail impact split.

Learn what is damage and what is not. Don't be fooled by fraudulent claims. Photos 2A, 2B, and 2C show

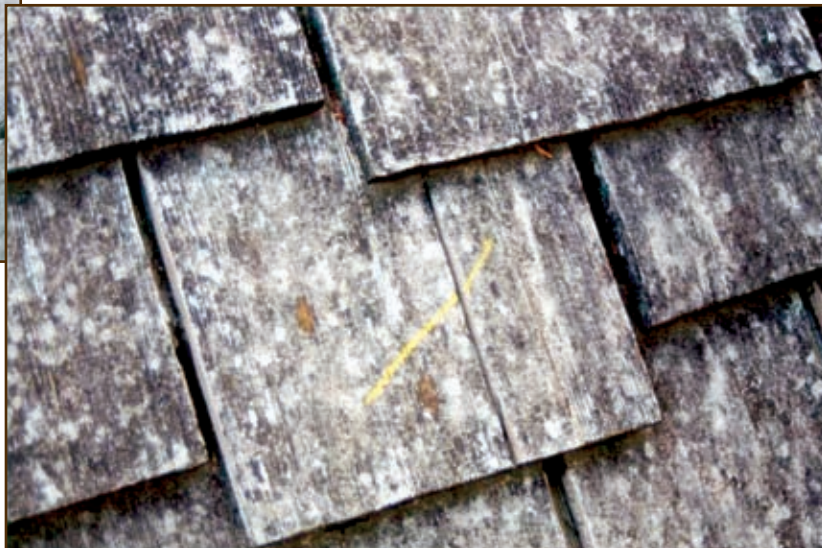
Photo 2B – Weathering split and small hail impact marks.

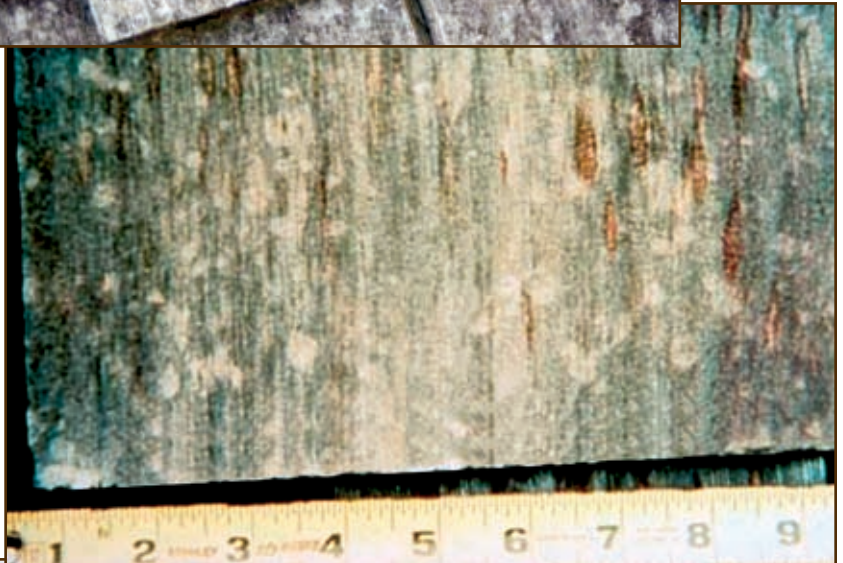
Photo 2C – Many small hail impact marks, but no splits in shingle.

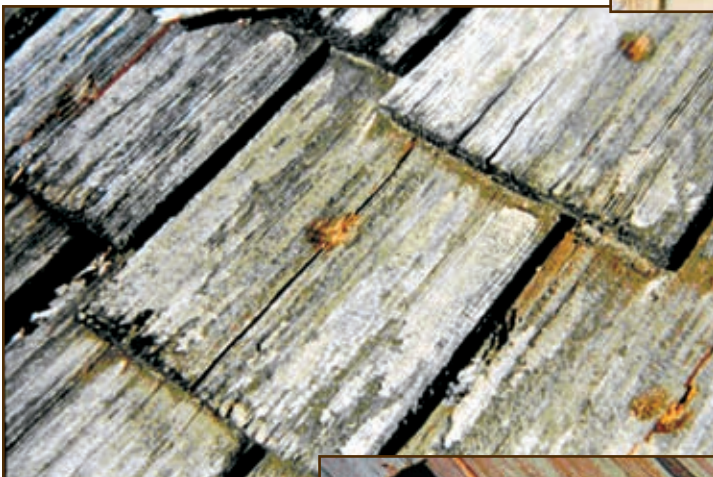
Photo 3A – Intentional ballpeen hammer damage (note regular pattern).

actual hail damage. *Photos 3A, 3B, and 3C* show damage on shakes and shingles that was not caused by hail.

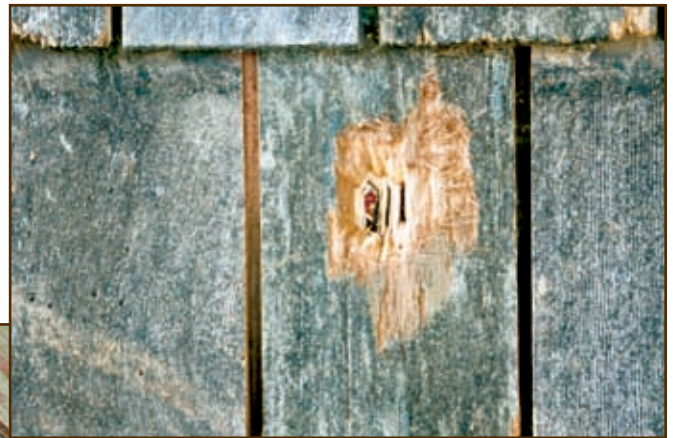
Photo 3C – Actual pressure-washing damage. This type of damage is typically caused by inexperienced equipment users. Contact CSSB for care and maintenance of cedar shingles and shakes.

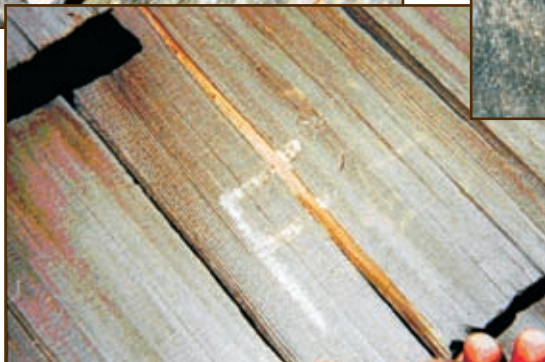
Photo 3B – Footfall split damage (note no denting and new cedar color).

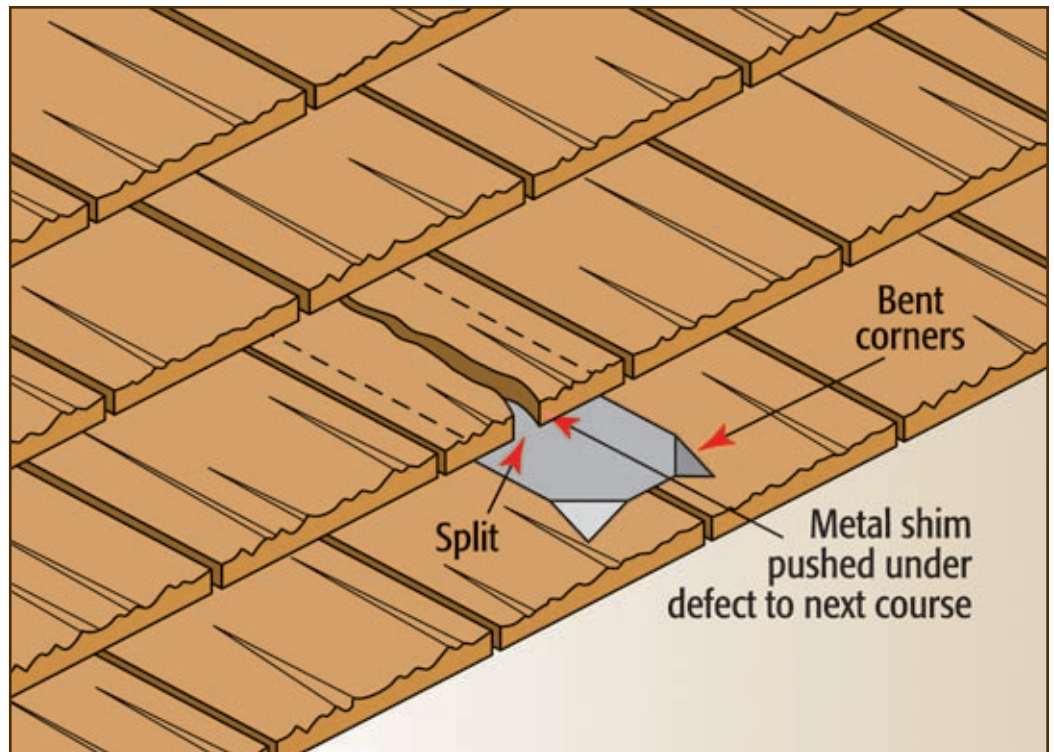
Figure 5 – In general, no more than 25 hail impact splits per 100 square feet should exist if shimming is to be used. Otherwise, consider using new shakes or shingles or replace the entire roof.

Shimming can be used to repair the odd shake or shingle, filling in a split piece from below. however, for purposes of both roofing system integrity and cosmetic appearance, no more than 20 percent of a roof area

should be shimmed (Figure 5). If this 20-percent limit is reached, one should consider repairing the area with new shakes or shingles or a complete reroof job, depending upon the circumstances and level of damage.
